# **INDOOR AIR QUALITY ASSESSMENT**

**Harvard Elementary School  
Old Wing  
27 Massachusetts Avenue  
Harvard, Massachusetts**

Prepared by:  
Massachusetts Department of Public Health  
Bureau of Environmental Health Assessment  
October 2002

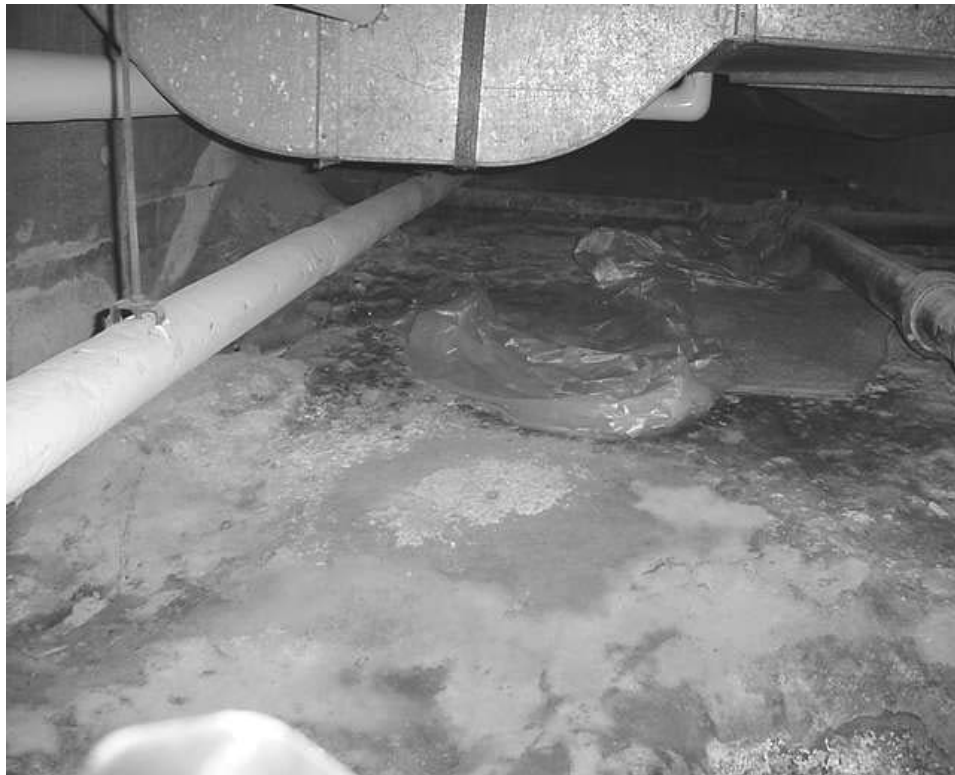
**Picture 1**

**Dirt Floor Of Crawlspace**

3. Consult a building engineer concerning the most appropriate method to provide active mechanical exhaust ventilation to place the crawlspace under negative pressure. Placing the crawlspace under negative pressure will reverse air penetration into occupied spaces. Please note that crawlspace exhaust vents should not expel crawlspace air near univent fresh air intakes.

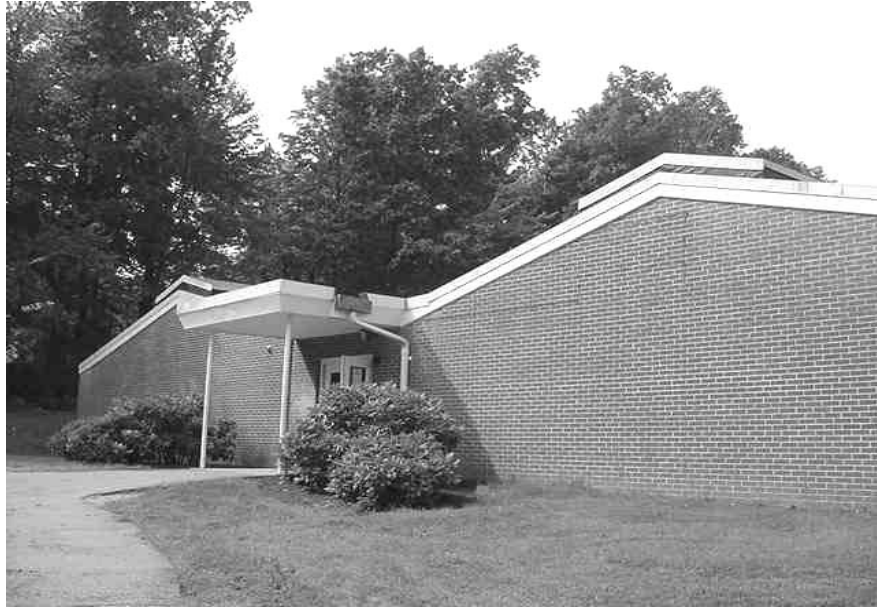
**Picture 2**

**Double-Peaked Roof Over Old Wing**

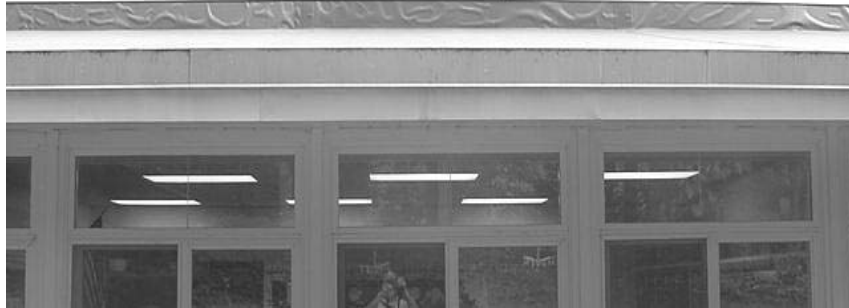
**Picture 3**

**South Roof Edge, Note Lack Of Gutter/Downspout**

1. Install gutters and downspouts along the eaves of all sloped roofs. Install downspouts in a manner to direct rainwater at least five feet from the north exterior wall to prevent pooling along the foundation.

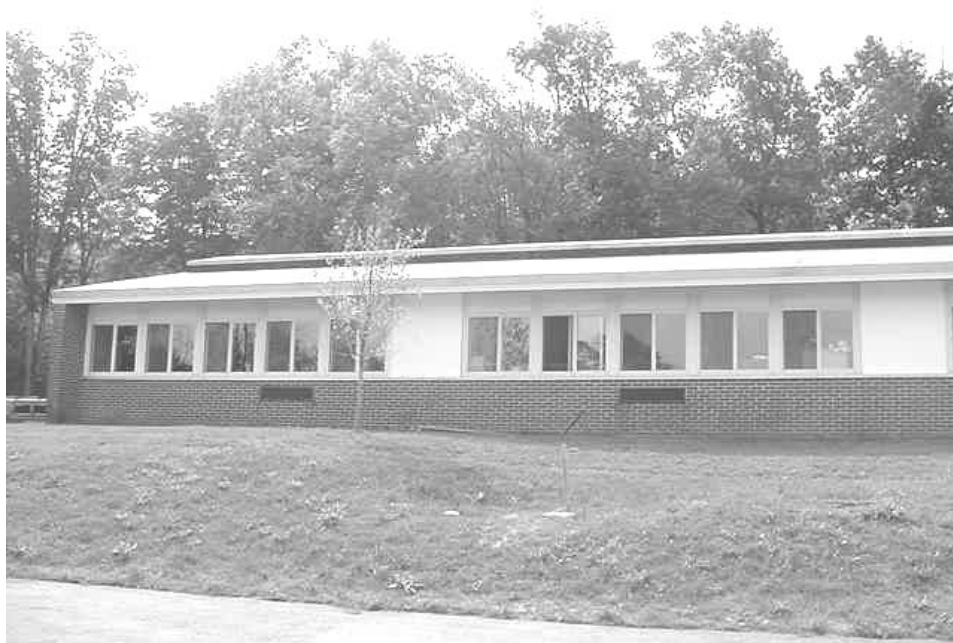
**Picture 4**

**North Roof Edge, Note Lack Of Gutter/Downspout**

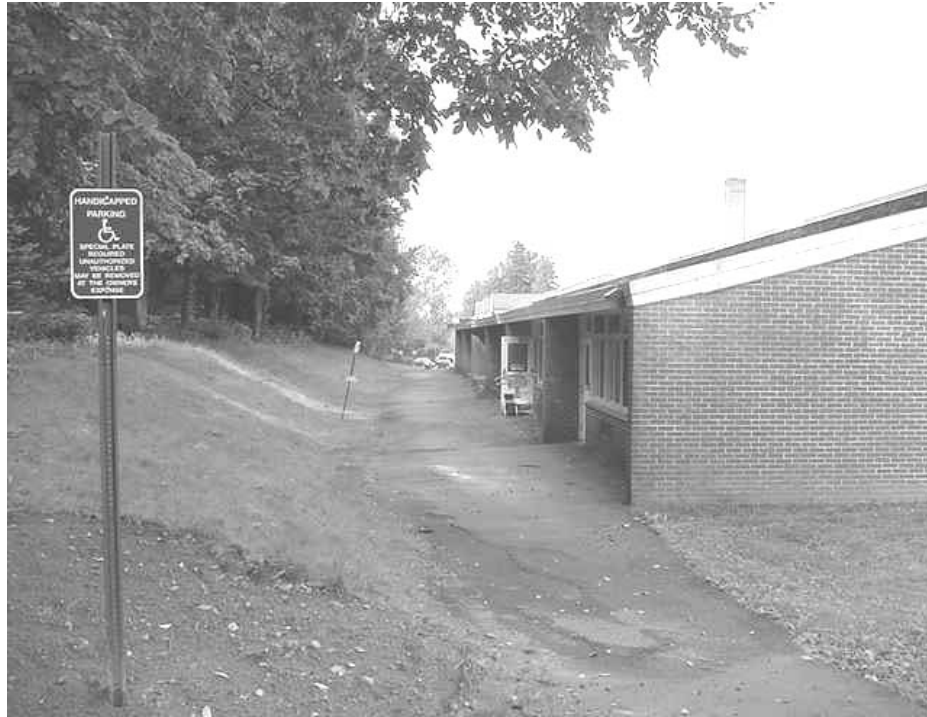
**Picture 5**

**Tarmac Driveway Along South Exterior Wall Of Old Wing**

2. Examine the feasibility of re-paving the tarmac apron on the south exterior wall to slope away from the edge of the building toward the storm drain. Once done, apply an appropriate sealant to the seam between the tarmac and building exterior wall.

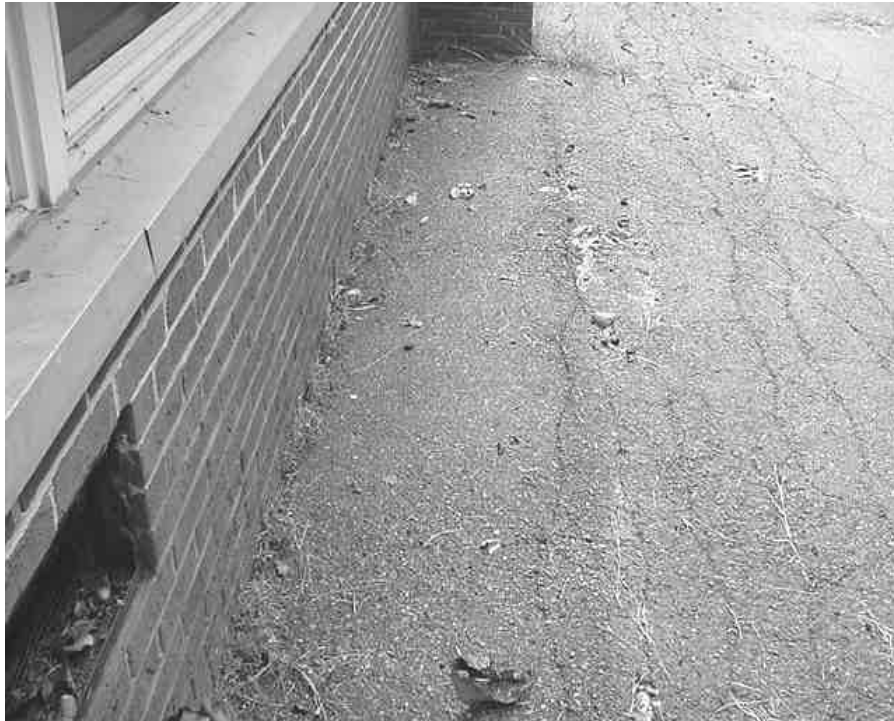
**Picture 6**

**Tarmac Sloped Towards South Exterior Wall Of Old Wing**

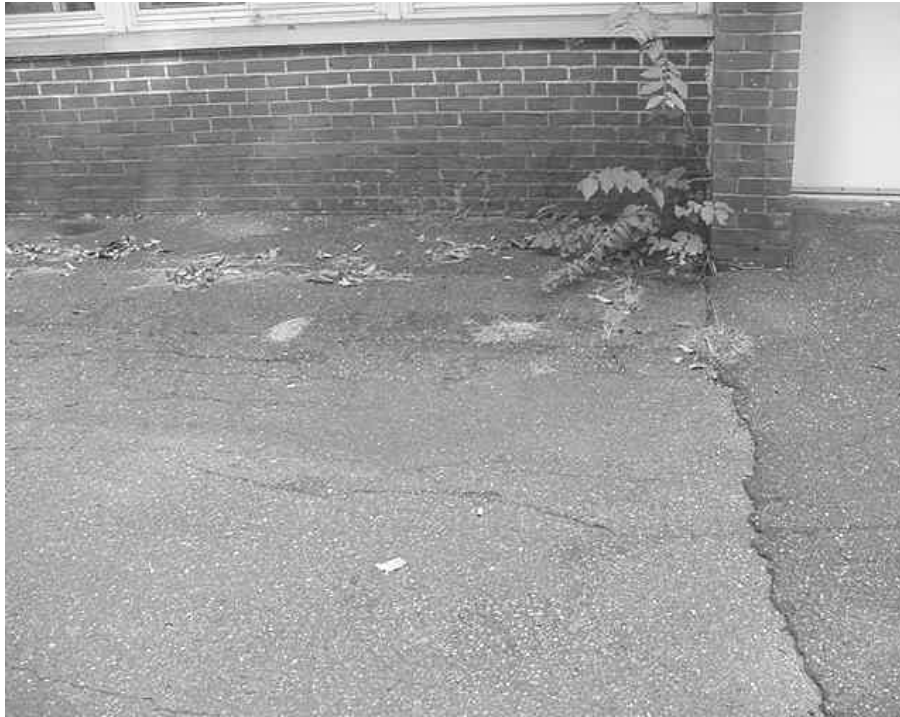
**Picture 8**

As noted in the previous report, a musty odor was detected in the main corridor of the old building. In the original report, BEHA staff attributed this odor to carpet in the main hallway (MDPH, 1999). The musty odor was detectable upon entering the old wing from the newer section of the building during this assessment. The crawlspace consists of a combination of cement foundation wall and a dirt floor (see Picture 1). The crawlspace had a musty odor, indicating that water penetration mixing with dirt may be creating microbial growth. The source of moisture penetrating the interior of the crawlspace appears to be runoff of rainwater from the roof system. The wing is covered with a double-peaked roof (see Picture 2). It does not appear that the roof is outfitted with rain gutters or downspouts (see Pictures 3 and 4). As a result, rainwater runs off the roof onto the ground at the base of the building. Over the years, this runoff has created a trench parallel to the base of the wall along the grass on the north side of the building. This trench allows rainwater and melting snow to pool against the foundation and the exterior wall. Rainwater from the south section of the roof of the building empties directly onto a tarmac apron at the base of the exterior wall (see Picture 5). It appears that it was intended to direct rainwater to storm drains. While the majority of the tarmac apron slopes to the storm drains, the apron beneath the roof edge appears to be sloped *towards* the foundation (see Picture 6), allowing rainwater to come into contact with the exterior wall/tarmac junction. A number of cracks and several potholes (see Pictures 7 and 8) have developed in the driveway, which will also allow water to accumulate and

**Cracks In Tarmac Along South Exterior Wall Of Old Wing**

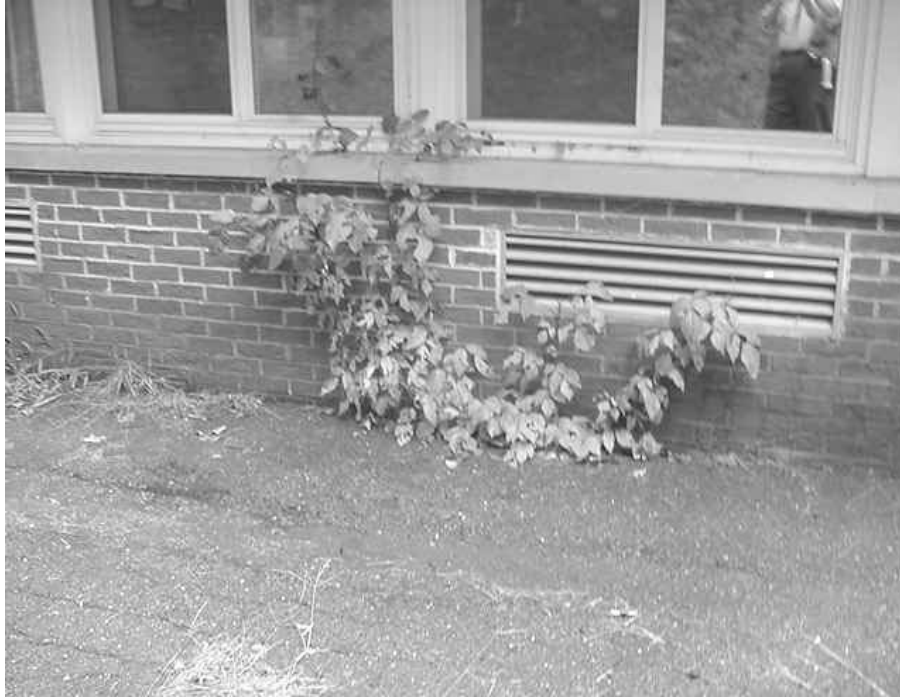
**Picture 9**

pool along the south wall of the building. Exacerbating this are a number of plants growing in the junction between the exterior wall and the tarmac (see Picture 9). Water can gather in the wall/tarmac seam where these plants were observed. Freezing and thawing of gathered water can result in damage to the exterior wall. Over time, this process can undermine the integrity of the building envelope and provide a means of water entry into the building through capillary action via foundation concrete and masonry (Lstiburek & Brennan, 2001). This condition may also allow for water to pass through the foundation walls to moisten the dirt of the crawlspace.

**Plants Growing From Tarmac/Exterior Wall Seam**

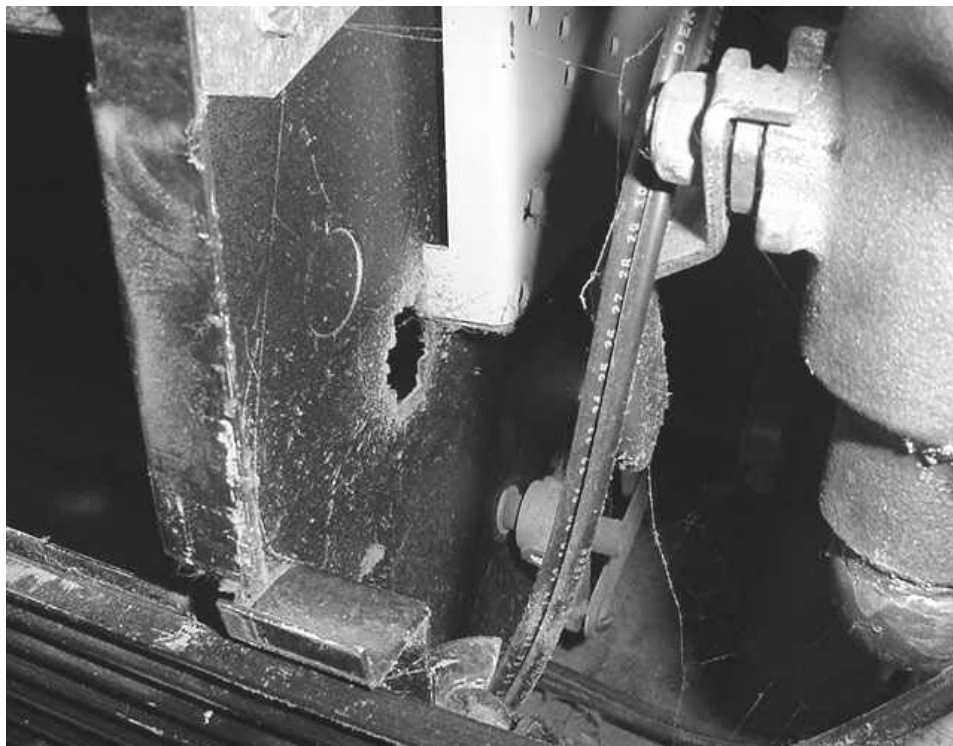
**Picture 10**

Several pathways exist for crawlspace air to migrate into occupied areas of this wing. The interiors of univents in the wing were spot-checked. Walls in which univents are installed have spaces and holes within the air handling cabinet (see Pictures 10 and 11). In addition holes exist in the floor for the univent heating pipes (see Picture 12). Spaces exist around heating pipes that can allow for air to be drawn from the crawlspace and be dispersed into classrooms by univent fans. Please note that holes also exist in the rear wall of univents that open into the exterior wall system. These holes can serve as pathways to draw air from the exterior wall cavities. The existence of these holes allows for air to by-pass univent filters, resulting in the aerosolization of materials (e.g. dust) into classrooms.

**Hole In Air Cabinet Wall**

4. Seal all holes in the walls of the univent air handling cabinets to limit filter bypass.  
Double sided, foil faced insulation with adhesive applied in a manner to create an airtight seal can be installed.
5. Seal wall and pipe floor holes within univent casing.
6. Seal walls in the rear of each univent cabinet to prevent air draw from the exterior wall cavity.
7. Remove all vegetation from the exterior wall/tarmac seam. Seal the exterior wall/tarmac junction with a water impermeable sealant.
8. Identify the purpose of the hallway floor vent. If its purpose is to serve as an exhaust vent, consider connecting the hole to the exhaust system using a flexible duct of sufficient diameter in order not to inhibit function.
9. Seal abandoned piped originally connected to hallway radiators.

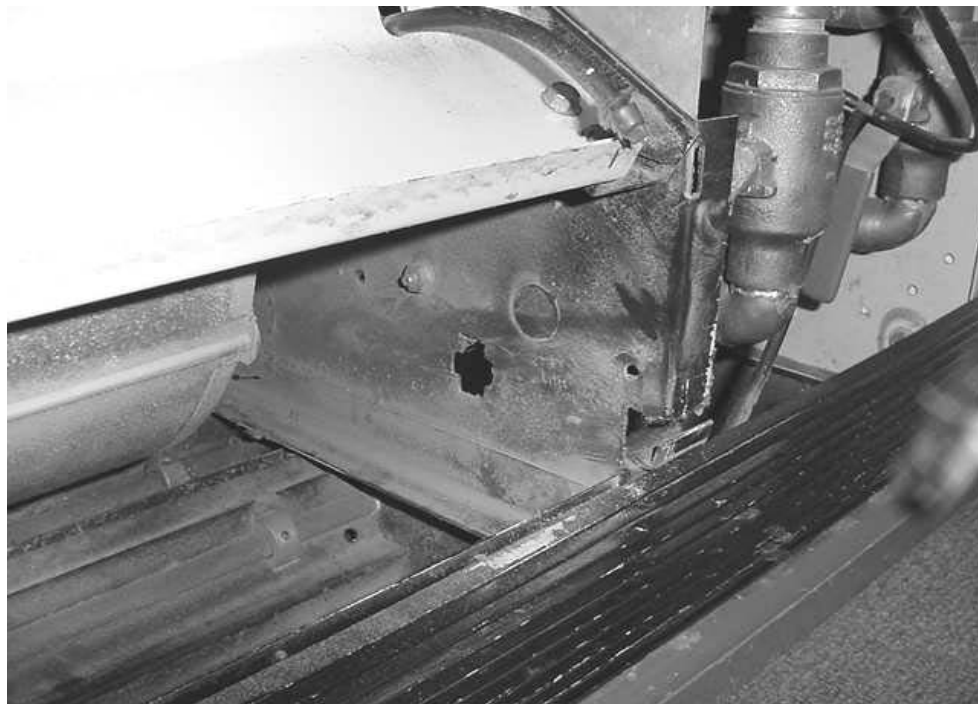
**Picture 11**

**Hole In Air Cabinet Wall**

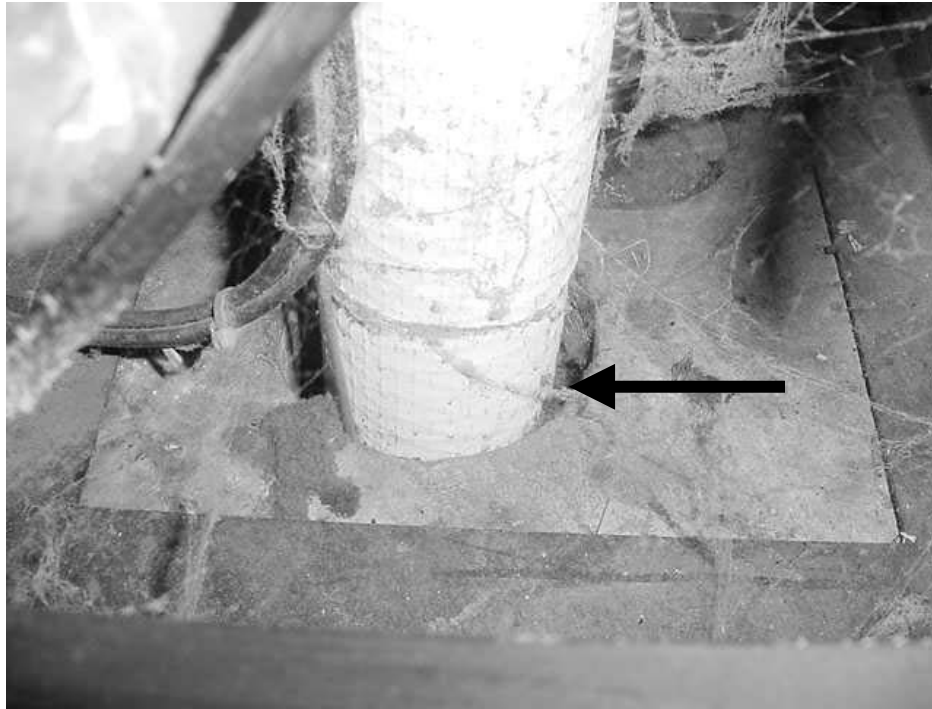
**Picture 12**

**Space Around Pipe Inside Univent Cabinet**

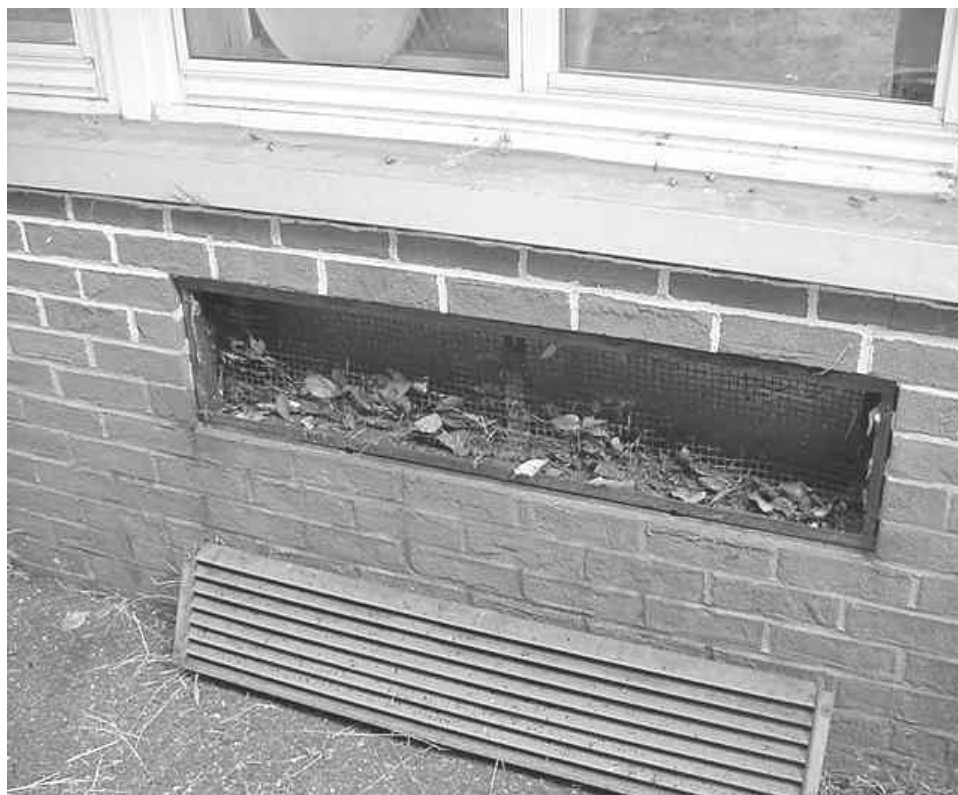
**Picture 13**

In an effort to determine if other sources of odors exist in the univents, the exterior louvered wall grate was removed. A significant amount of moistened outdoor debris was found between the exterior louvered wall grate and bird screen (see Picture 13). This material can serve as a mold growth medium, producing odors and mold spores.

**Debris Inside Fresh Air Intake Louver**

1. Continue to implement the recommendations made in the previous BEHA report.
2. Remove accumulated debris inside univent fresh air intake grilles.
3. Clean accumulated particulates from the air handling and control cabinets of each univent.

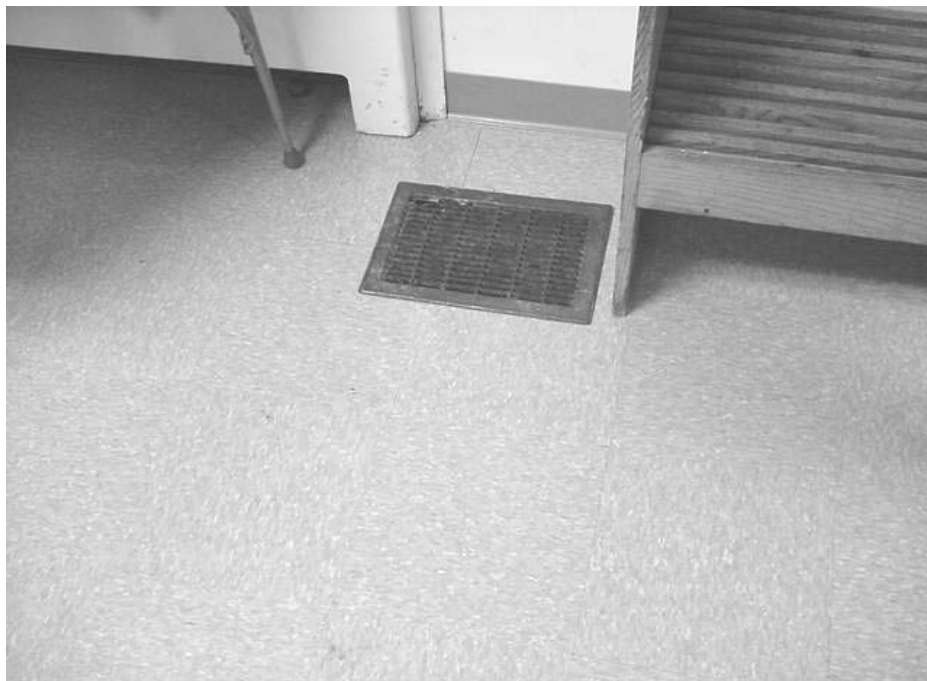
**Picture 14**

A grated hole was noted in the floor of the hallway (see Picture 14). The grate was removed, revealing that it opened directly into the crawlspace. It is possible that the hole serves as an exhaust vent for the hallway. Assuming the hole was designed as part of the hallway exhaust system, this configuration has a number of drawbacks that would limit its usefulness:

1. If the hallway ventilation system is deactivated off hours, this hole now serves as a migration path for crawlspace air into occupied space. With the ventilation system deactivated, heated air from uninsulated HVAC system pipes and the boiler room can create drafts that rise from the crawlspace into the hallway. This column of moving air can then draw mold, spores and associated odors from the crawlspace, which then can accumulate in the hallway overnight.
2. This configuration draws air into the crawlspace as an uncontrolled pathway. The ungrated hole can serve as a means for fire to spread from the hallway into the crawlspace.
3. The exhaust vent for the duct appears to be heavily coated with debris that has fallen through the hole. This type of accumulation may result in the deterioration of the duct.

**Grate In Floor Of Hallway**

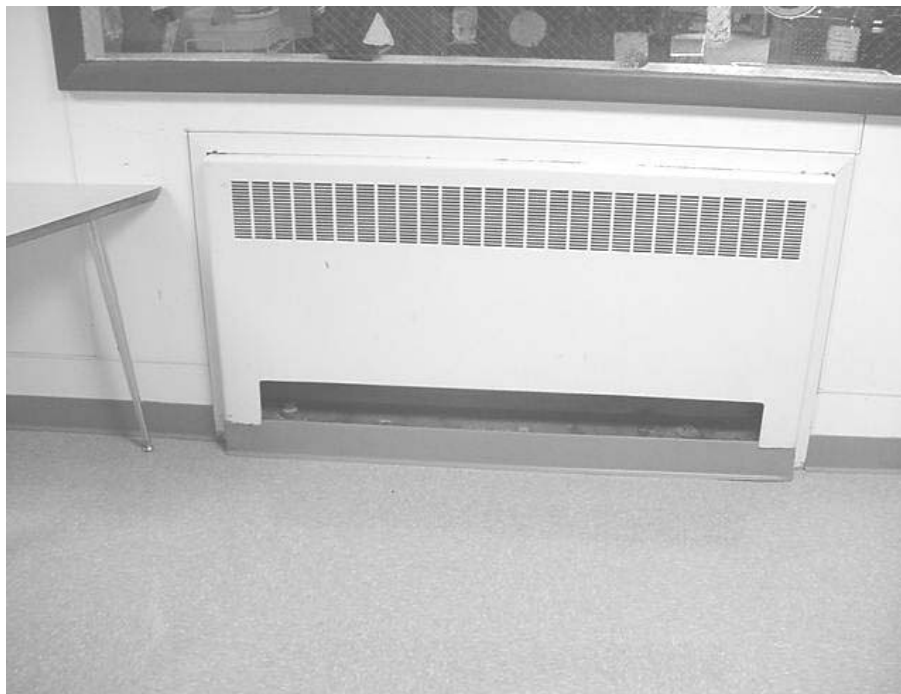
**Picture 15**

The renovation that added the new wing appears to have abandoned hallway radiators (see Picture 15). Heating pipes were cut from the radiators. Similar pipes were noted in the crawlspace. Since neither end of these pipes appeared sealed, each of them may serve as pathways for crawlspace air to penetrate into the hallway.

**Abandoned Hallway Radiators**

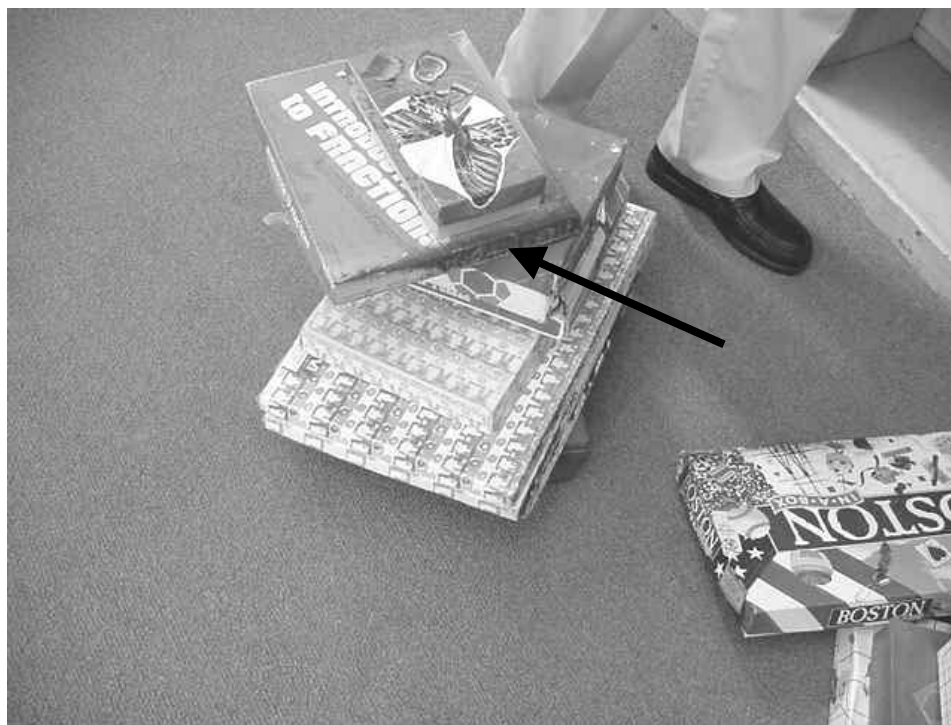
**Picture 16**

During the course of this assessment, a teacher had indicated that a problem existed in an interior wall of classroom 111. An examination of this wall revealed microbial growth in gypsum wallboard (GW), behind a shelf. A number of boxes stored on this shelf (see Picture 16) and the carpet (see Picture 17) appeared to be colonized with microbial growth. On the opposite side of the mold colonized wall is a custodial closet (see Picture 18). Several linear feet of GW within the custodial closet also had corresponding mold colonization. The source of moisture appears to be plastic hoses connected to a cleaning solution dispenser (see Picture 19 and 19A). The purpose of the dispenser is to provide an appropriate mix of tap water and cleaning solution, which is then dispensed into a mop bucket for use via the plastic hoses. After filling, an amount of cleaner/water solution remains in the plastic hose. Since soap is a surfactant that can reduce the capillary action of water, the addition of cleaner will allow for water to more readily run out of the tube. For this reason, the tube used to deliver the cleaner/water solution should be placed inside the sink to drain the residue. Dispenser hoses were found touching the floor beside the sink, which would allow for the cleaner/water solution to empty onto the floor and moisten GW. The most obvious mold growth on GW was observed in close proximity to mop buckets and the cleaning solution dispenser's hoses.

**Mold Colonized Boxes, Room 111**

1. Remove mold contaminated GW in a manner consistent with recommendations found in “Mold Remediation in Schools and Commercial Buildings” published by the US Environmental Protection Agency, Office of Air and Radiation, Indoor Environments Division, Washington, DC. EPA 402-K-01-001. March 2001.  
Copies of this document can be downloaded from the US EPA website at:  
[http://www.epa.gov/iaq/molds/mold\\_remediation.html](http://www.epa.gov/iaq/molds/mold_remediation.html)
2. Remove and discard mold contaminated carpet and shelves from room 111.

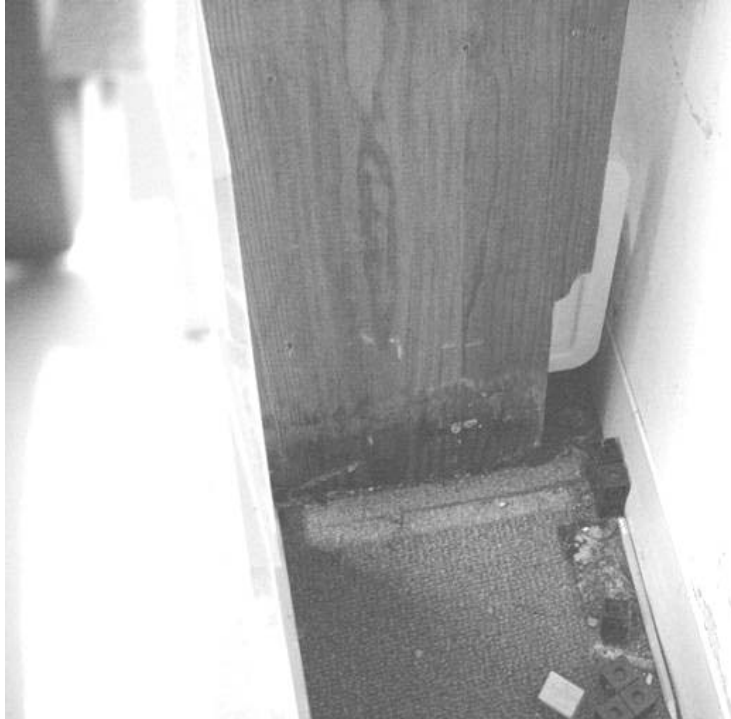
**Picture 17**

**Mold Colonized Wooden Shelves And Carpet, Room 111**

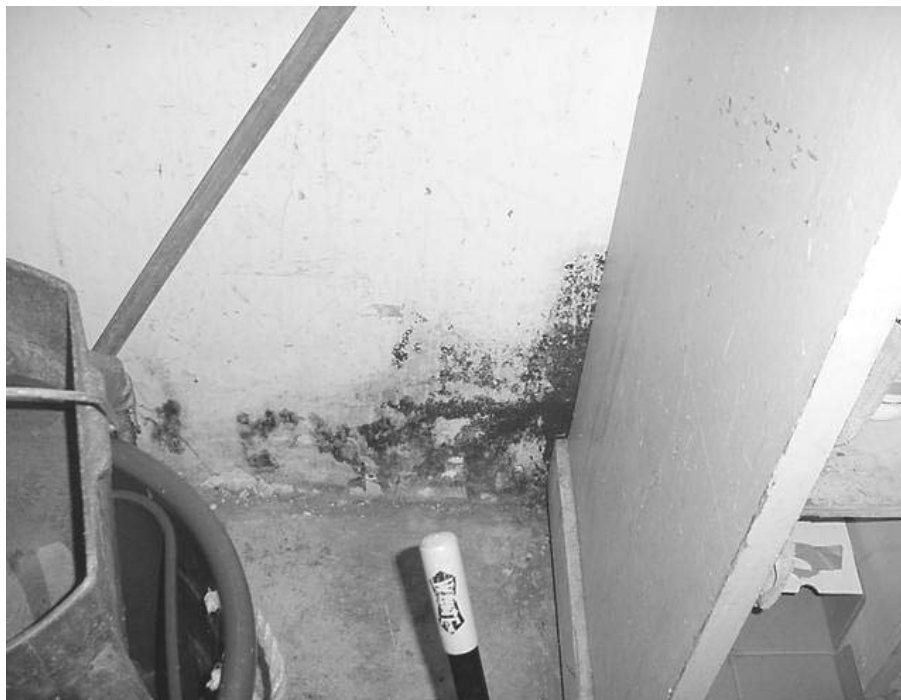
**Picture 18**

**Mold Colonized Gypsum Wallboard In Custodial Closet**

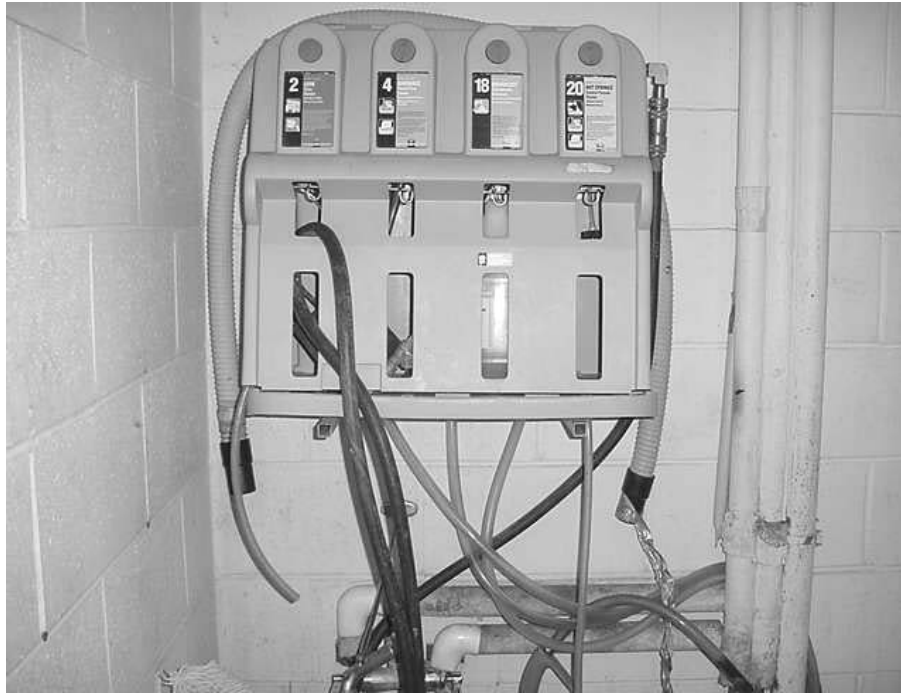
**Picture 19**

**Cleaner Dispenser, Note Hoses**

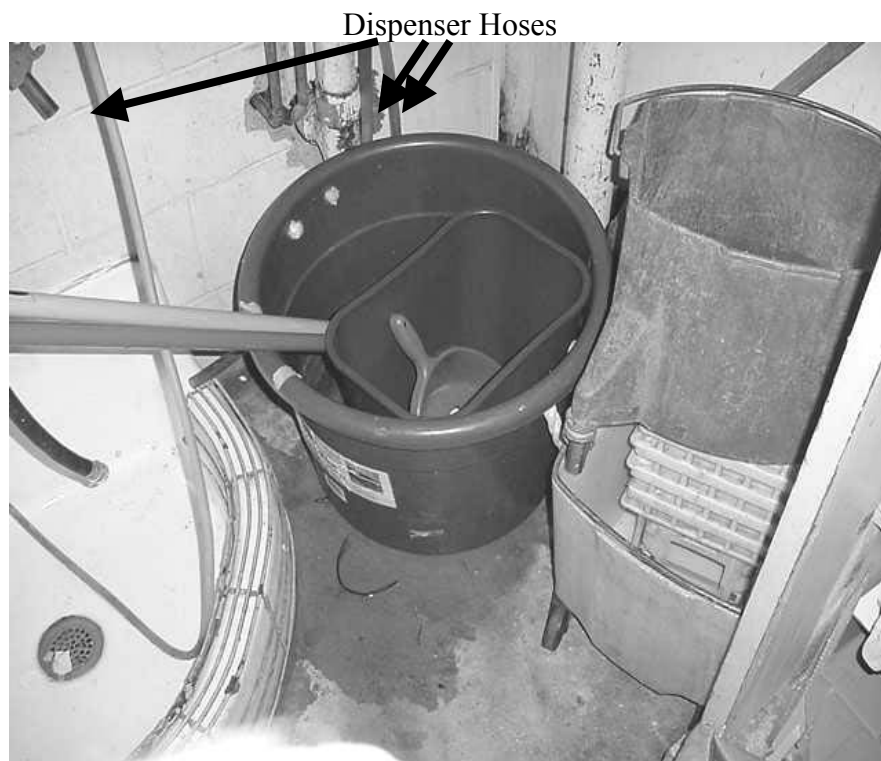
**Picture 19A**

**Cleaner Dispenser Hose, Note Moistened Floor And Hoses**
